Silicon identification

This document applies to the STM32F098CC/RC/VC devices and their silicon revisions shown in [Table 1](#).

[Section 1](#) gives a summary and [Section 2](#) a description of device limitations, with respect to the device datasheet and reference manual RM0091.

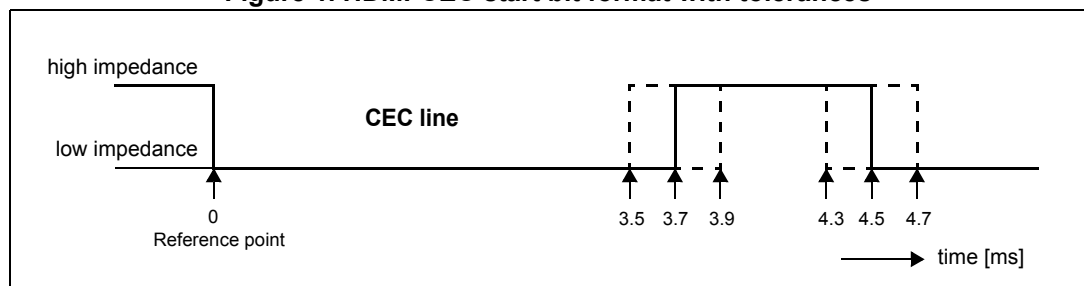
Figure 1. HDMI-CEC start bit format with tolerances

When the HDMI-CEC communication start bit transmitted by the device is corrupted by another device on the CEC line, the CEC transmission is stalled.

The start bit timing standard tolerances are shown in [Figure 1](#). The start bit is initiated by the device by driving the CEC line low (reference point). After 3.7 ms, the device releases the CEC line and starts checking its level. The following conditions must be met for the start bit to be valid:

- the CEC line goes high no later than 3.9 ms (4.05 ms with extended tolerance) from the reference point
- a falling edge on the CEC line does not occur earlier than 4.3 ms (4.15 ms with extended tolerance) from the reference point

If one of these conditions is not met, the transmission is aborted and never automatically retried. No error flag is set and the TXSOM (Tx Start Of Message) bit is not cleared.

A way to work this limitation around is for the system-level CEC application software to start a time-out counter when setting TXSOM bit and stop it upon TXBR or TXEND event. In case of time-out, the HDMI-CEC functional block is disabled then enabled, by setting the CECEN bit in CEC_CR register to 0 then to 1. This clears the TXSOM bit.
